Manhole Inspection Summary

Manhole # S21A__016MH

Insp Date: **10/18/07 12:07 PM**

Location Address: **721 MONROE ST**

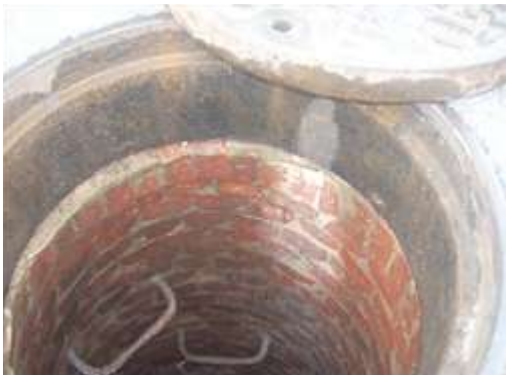
Defect 4

Infiltration: ☐ None ☒ **Joint** ☐ Cracks ☐ Mortar ☐ Roots ☐ Wall

CORBEL JOINT INFILTRATION

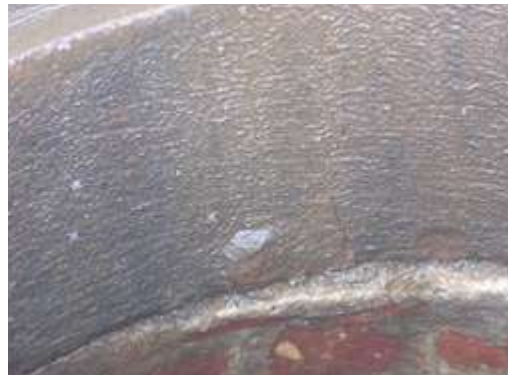
Defect 3

Condition: ☐ Sound ☒ **Cracked** ☐ Leaks

CRACKED FRAME

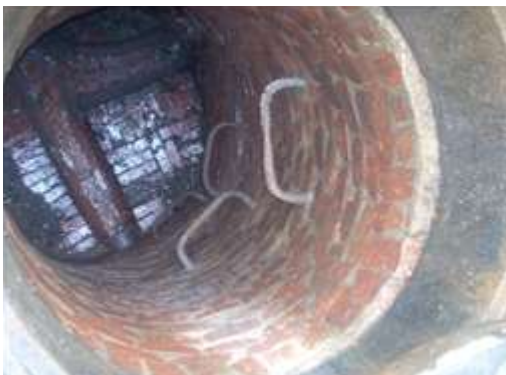
Defect 2

Count: **4** Missing: **0** ☒ **Corroded**

CORRODED STEPS

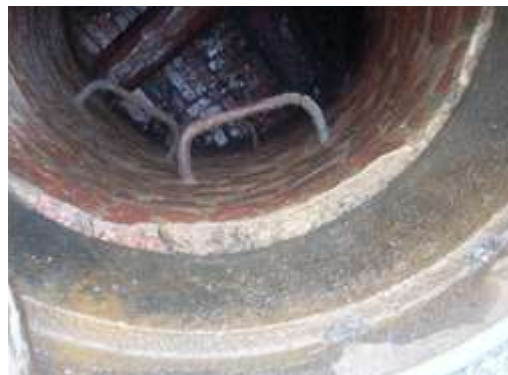
Defect 1

Offset: **1** (in.)

FRAME OFFSET

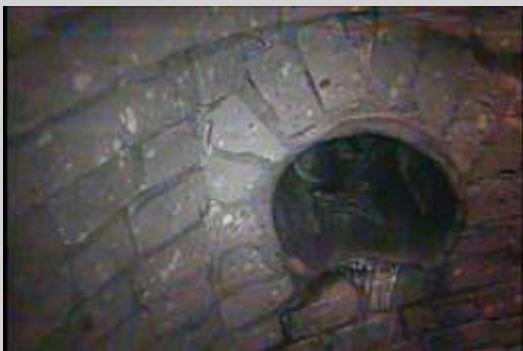
3 O'Clock Inflow

FRAME OFFSET

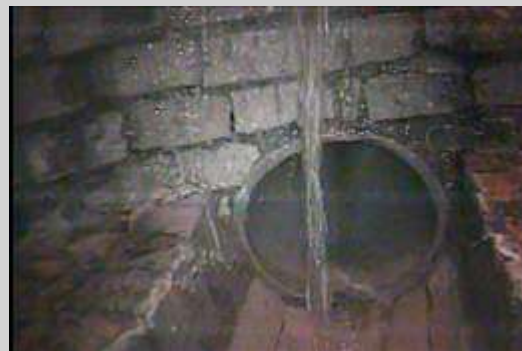
Drop In @ 3 O'Clock

FRAME OFFSET

Drop: **Outside** Rod and Bar
Angled: **Yes** Reading: **7.10** (ft.)
Inv Depth: **8.10** (ft.)
Drop Condition: **Clogged**
